**DEPARTMENT OF TRANSPORTATION**

Contract #: 04-0120F4Cty: SF/ALA Rte: 80 PM: 13.2/13.9File #: 69.28**WELDING INSPECTION REPORT****Resident Engineer:**Pursell, Gary**Address:** 333 Burma Road**City:** Oakland, CA 94607**Report No:** WIR-010072**Date Inspected:** 17-Oct-2009**Project Name:** SAS Superstructure**OSM Arrival Time:** 645**Prime Contractor:** American Bridge/Fluor Enterprises, a JV**OSM Departure Time:****Contractor:** Zhenhua Port Machinery Company, Ltd (ZPMC), Changxing Island **Location:** Shanghai, China**CWI Name:** Yu Dong Ping.**CWI Present:** Yes No**Inspected CWI report:** Yes No N/A**Rod Oven in Use:** Yes No N/A**Electrode to specification:** Yes No N/A**Weld Procedures Followed:** Yes No N/A**Qualified Welders:** Yes No N/A**Verified Joint Fit-up:** Yes No N/A**Approved Drawings:** Yes No N/A**Approved WPS:** Yes No N/A**Delayed / Cancelled:** Yes No N/A**Bridge No:** 34-0006**Component:** Tower Components**Summary of Items Observed:**

Bay11, South Tower, Strut Plate.

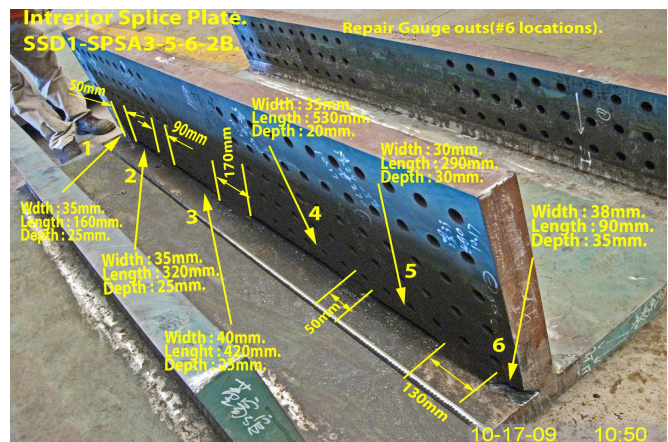
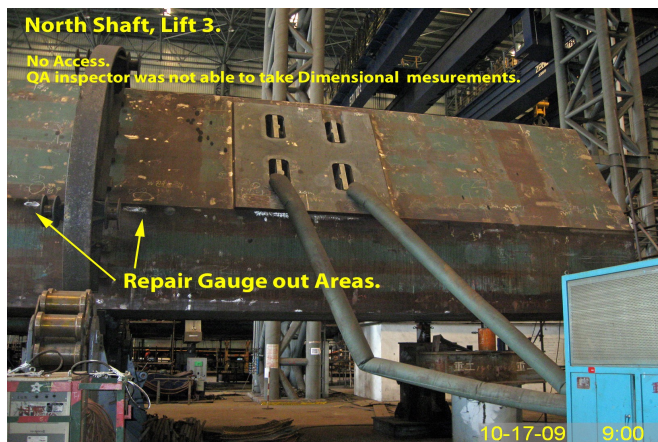
Bay11, North Tower, Lift 3.

Repair gouge outs noticed on North Tower, Lift 3, Skin B. There as No Access Available, so this QA could not take dimensional measurements. See attached pictures for details.
